# CHANILAND

# BIG BORE

### 750 KIT INSTALLATION INSTRUCTIONS

## 750cc Triumph Kit

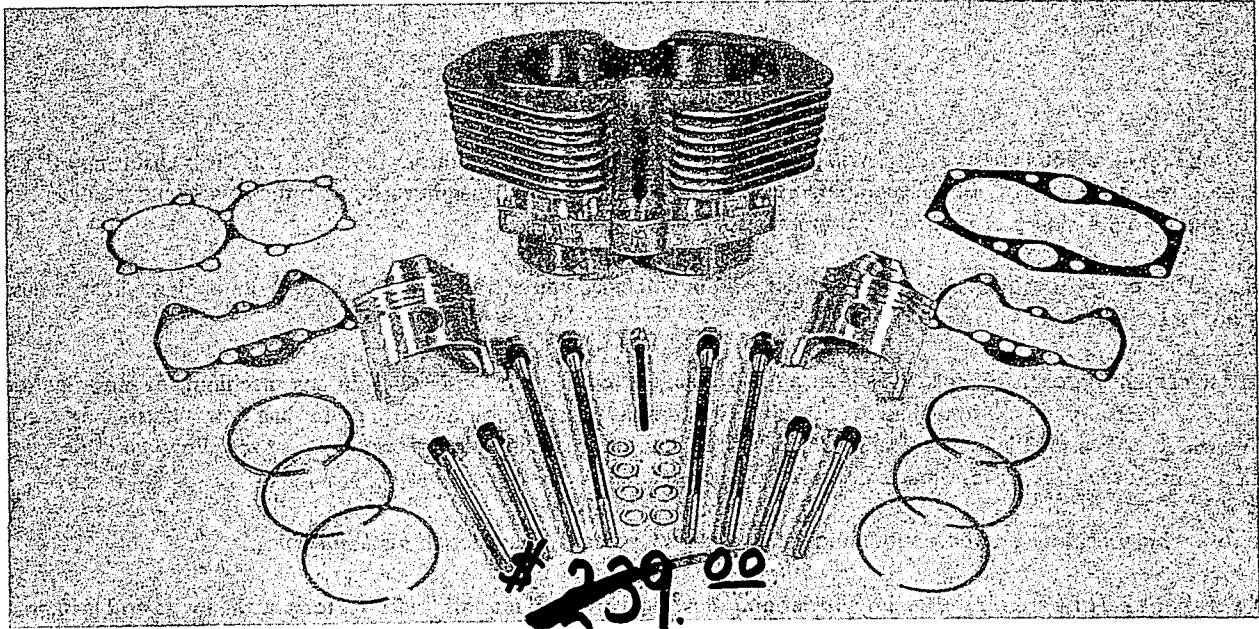
### TECHNICAL INFORMATION

Tempered 356 - T6 aircraft aluminum alloy cylinder is 7 lbs. lighter, yet stronger than cast iron cylinders • Polished fins match cylinder head - dissipates heat twice as fast • Box shaped inner body eliminates distortion • Roll extended threads, can't strip • Replaceable precision ground chrome - nickel alloy sleeves are extremely wear resistant • Only cylinder kit which features replaceable copper wire o-rings to insure a perfect seal on the head gasket surface • Cylinder head studs are manufactured from "stressproof" steel and are slotted for fast installation • 9.5:1 (road and street) or 10.5:1 (racing) pistons are manufactured from a low expansion, high silicone content aluminum alloy • Perfect circle rings are furnished and each piston is precision fitted to a 3.000" cylinder bore • Over sized pistons and rings are immediately available up to 3 oversizes.
